# Your Inspection Report

11111 Sample Street  
Houston, TX 55555

**INSPECTION DATE:**  
Friday, July 4, 2014

**PREPARED BY:**  
Greg Bryan License 3608

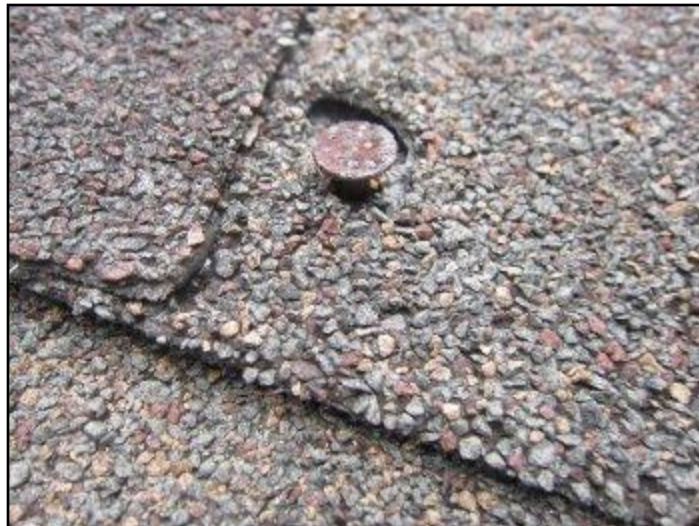
1. **Condition:** • Popped up nail heads observed. Remedy as needed to prevent possible damage to roof covering.

1. *Lifted nail heads*

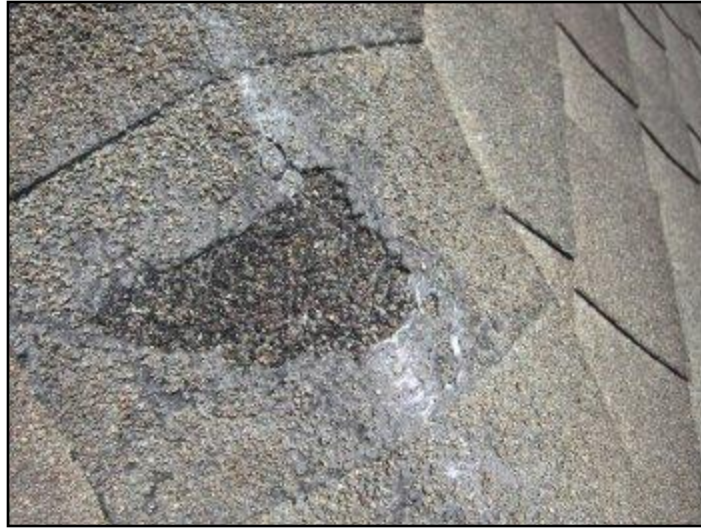
2. **Condition:** • Missing, loose and/or torn roofing shingles are observed. Evaluate and remedy as needed.

*2. Missing, loose and/or torn roofing shingles...*

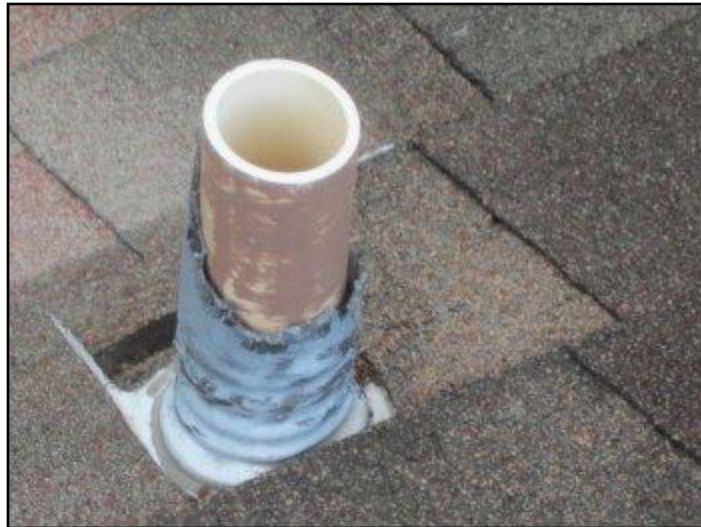
**3. Condition:** • Lead vent sleeves are deteriorated which may allow for water penetration between the lead vent sleeves and the plumbing vent(s).

*3. Lead vent sleeves are deteriorated which ma...*

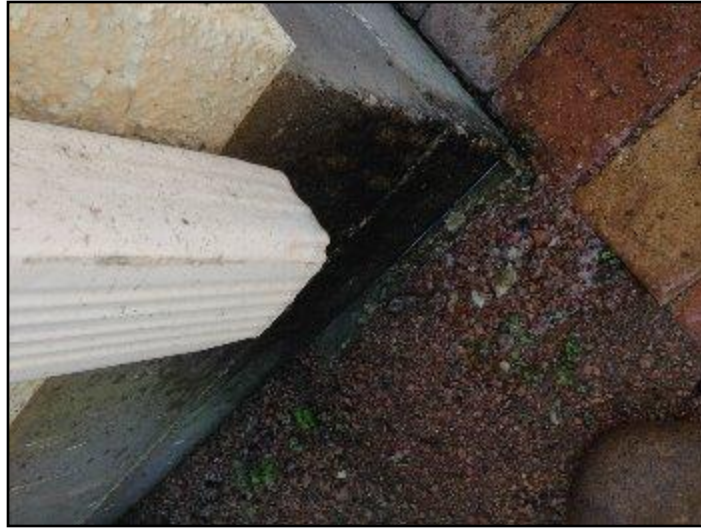
4. **Condition:** • Replacement of any missing "kick-outs" at the base of the gutter downspouts is recommended to direct water away from the foundation.

5. Replacement of any missing "kick-outs" at...

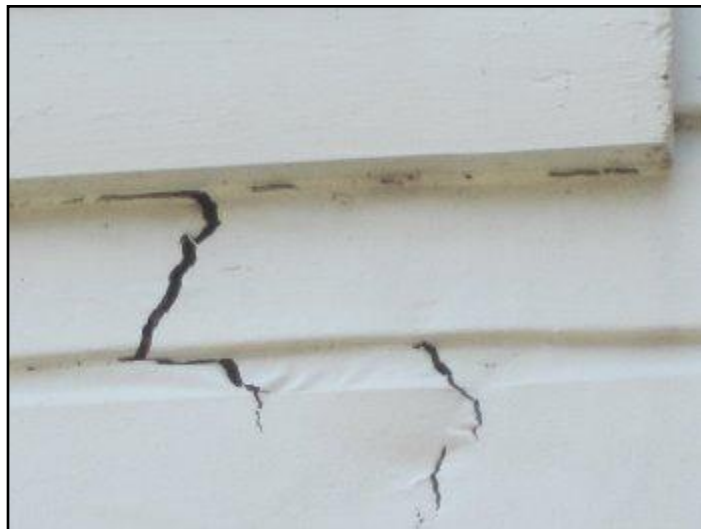
6. **Condition:** • Water damaged siding panels are observed at the left exterior wall beneath the upper window: evaluate and remedy as needed.

6. Water damage

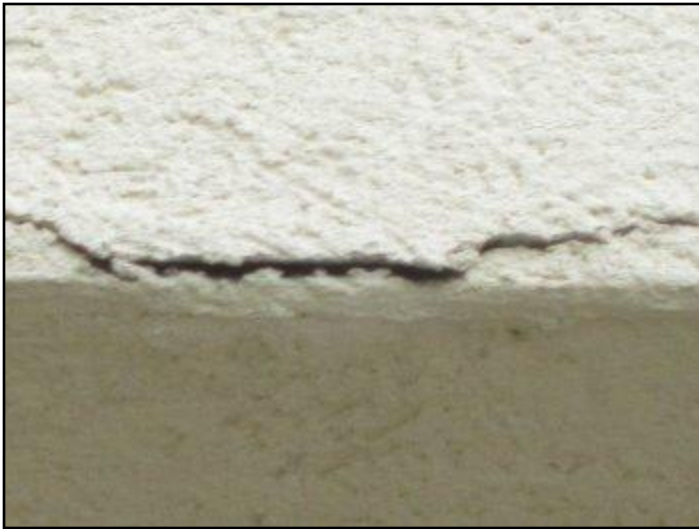
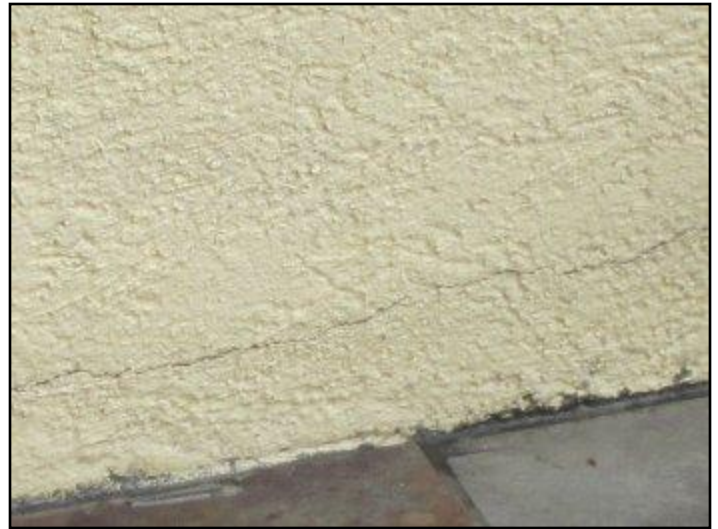
7. **Condition:** • Stress cracks are observed on the exterior veneer which may allow for water intrusion: evaluate and remedy as needed. .

7. Cracked siding

8. Cracked siding

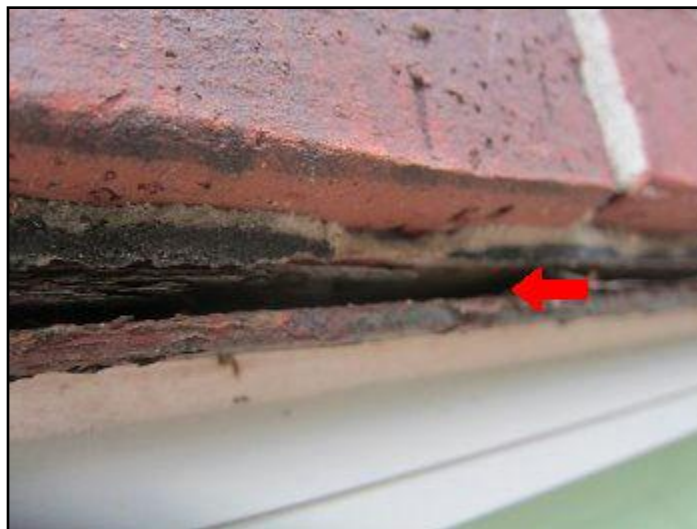
**9. Condition:** • Significant rusting is observed on the metal brick lintels above the right side windows: evaluation by a qualified brick mason is recommended to determine the best method of remedy.

9. Rusted lintel(s)

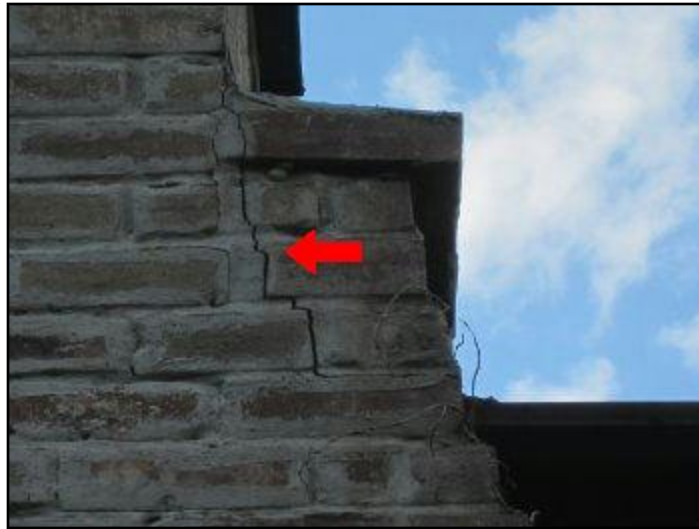
**10. Condition:** • Hairline cracks are observed in the masonry siding. Hairline cracks may be a result of thermal expansion of the veneer and/or normal structural movement.

10. Hairline cracks are observed in the masonry...

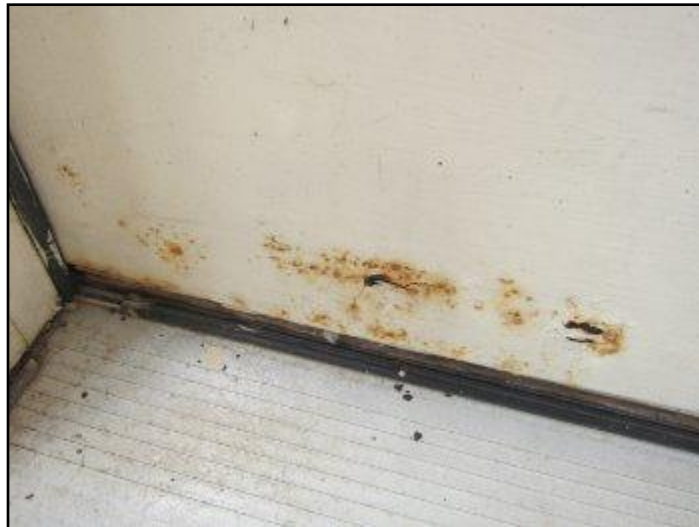
11. **Condition:** • Surface rusting is observed on the garage side entry door: remedy as needed.

11. Rusted door facing

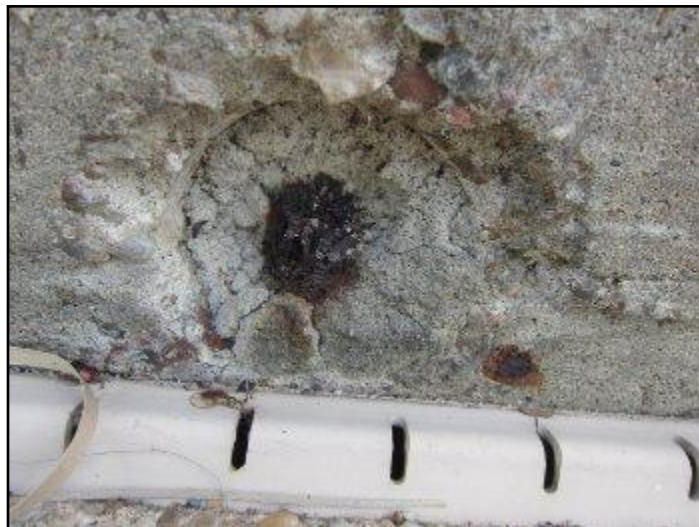
**13. Condition:** • Exposed "post-tension" cable tendons at the foundation parameter facing are exposed due to spalling concrete off of the cable ends. The exposed cables should be evaluated for excessive rusting then cleaned and sealed to prevent rusting and deterioration.

**12.** Exposed "post-tension" cable tendons at the...

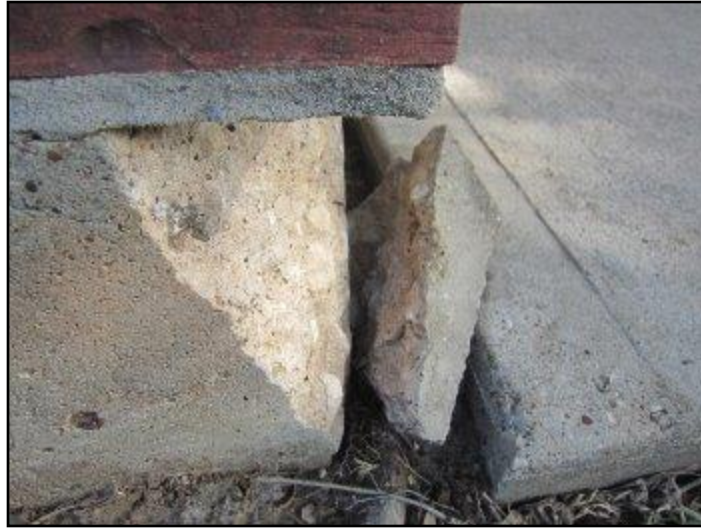
**14. Condition:** • Corner(s) of the concrete foundation have cracked and/or "sheared" off. While this will not negatively affect the foundation performance, re-sealing of these cracked foundation corners is recommended.

13. Corner(s) of the concrete foundation have...

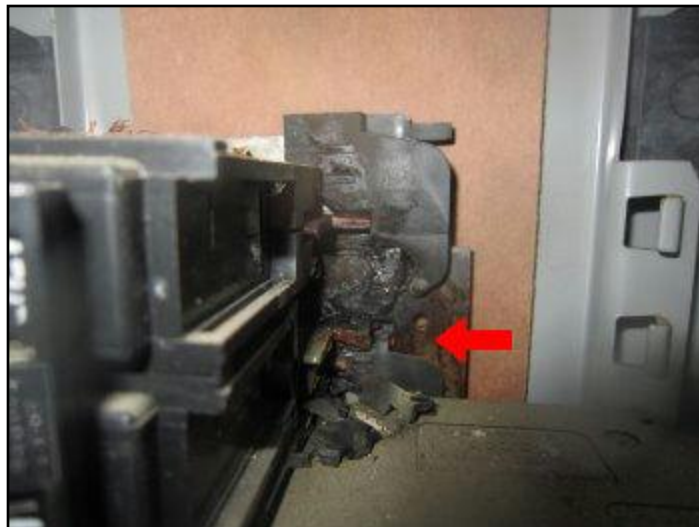
**16. Condition:** • There is evidence of overheating inside the breaker box at the main service disconnect (hazard): evaluate and remedy as needed.

14. Overheating

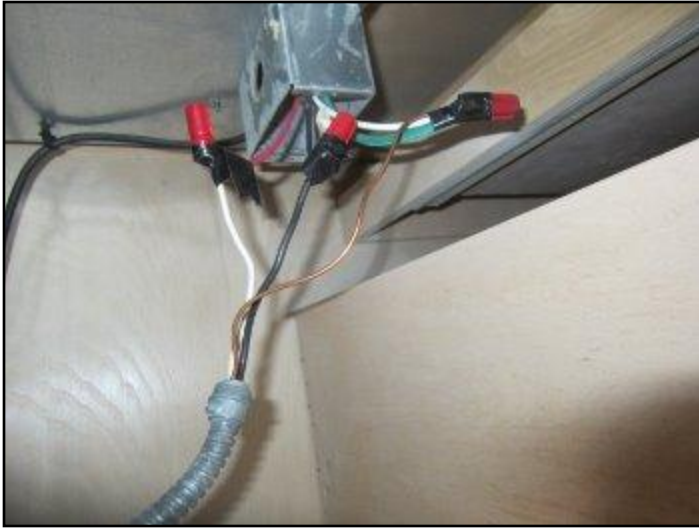
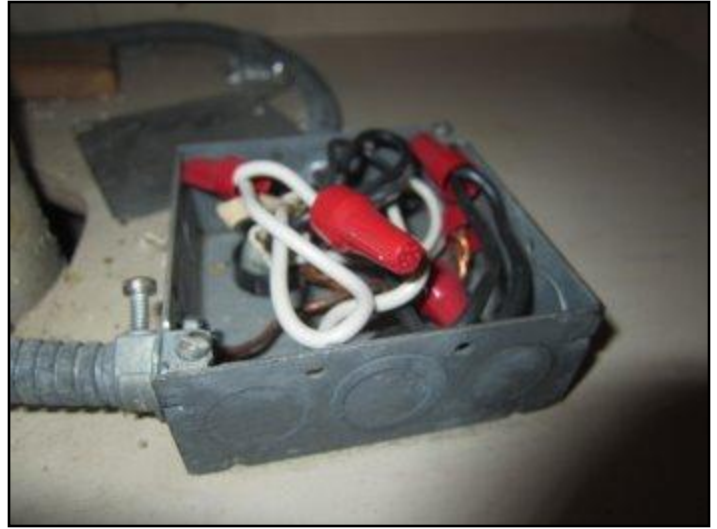
**17. Condition:** • Wire splices are not installed in a sealed junction box for safety at the kitchen cooktop and under the oven.

15. Open splices

16. Open splices

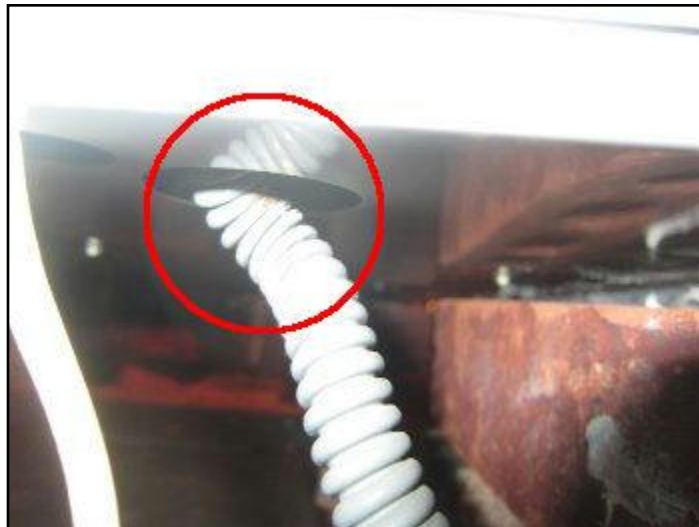
**18. Condition:** • The gas branch line routed into the furnace casing is flex line; current building standards require hard piping extend outside the furnace casing and then attach the flex line to the hard pipe outside the furnace.

17. The gas branch line routed into the furnace...

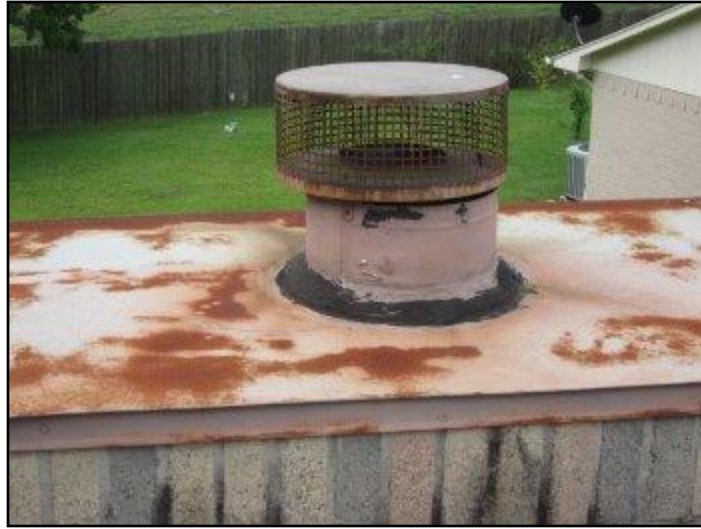
**20. Condition:** • Surface rusting is observed on the metal chimney cap: evaluate and seal as needed.

**18.** *Surface rusting is observed on the metal...*

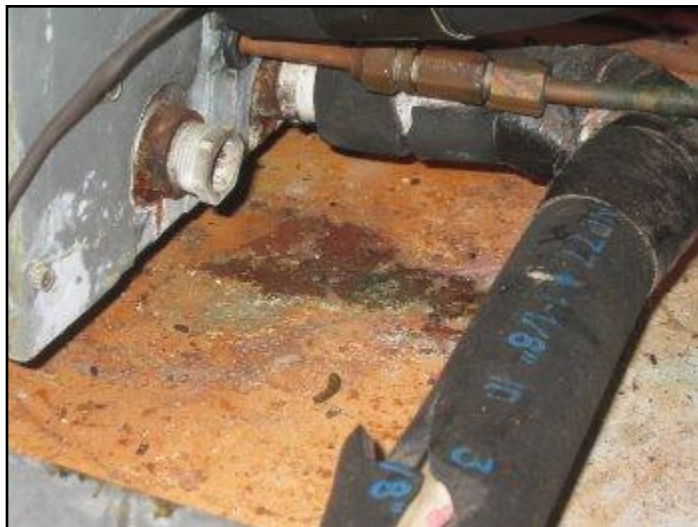
**22. Condition:** • Rusting in the evaporator condensate overflow pan indicates possible blockage of the condensate drain line(s) and a dirty evaporating system: service of the system is recommended.

19. Rusting in the evaporator condensate...

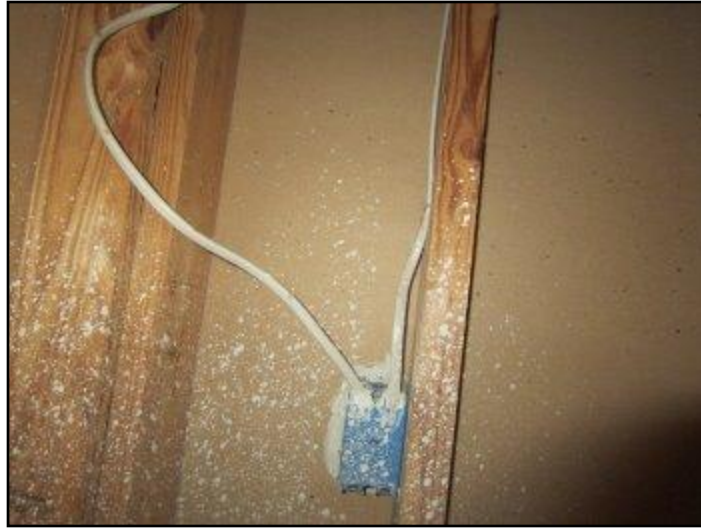
**23. Condition:** • Insulation is fallen and/or displaced at areas of the attic walls: replace as needed.

21. Insulation is fallen and/or displaced at...

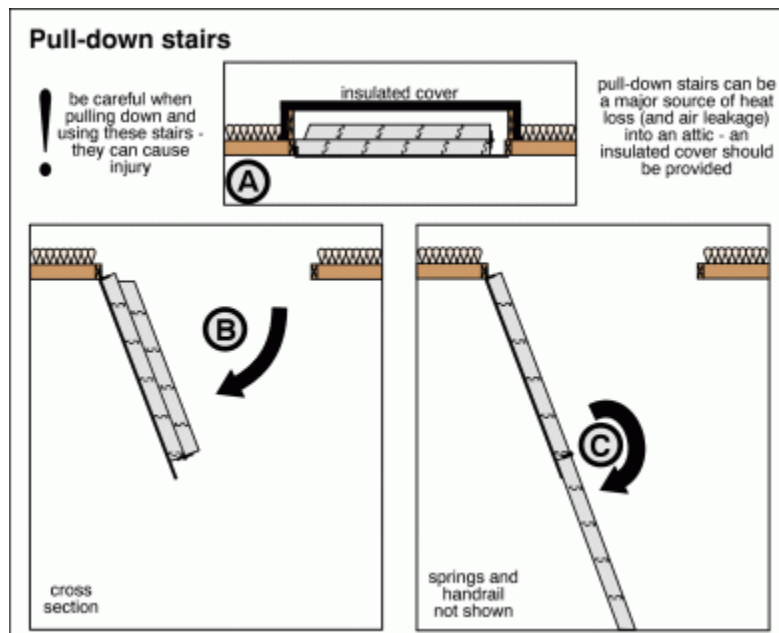
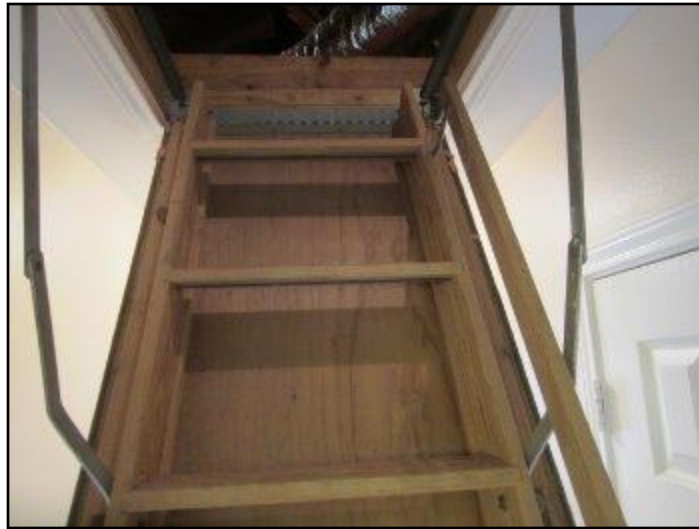
24. Condition: • [Not insulated](#)

**22.** *Not insulated*

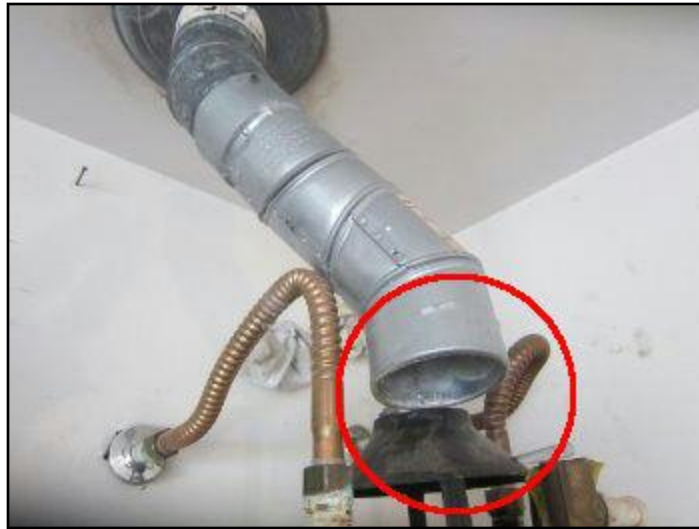
**25. Condition:** • The combustion vent pipe is displaced at the top of the unit preventing proper venting to the exterior of the structure (hazard): remedy as needed.

23. The combustion vent pipe is displaced at th...

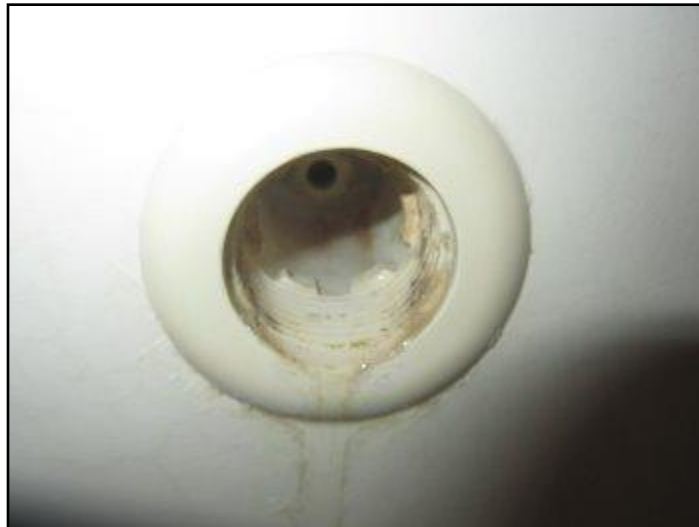
26. Condition: • Water ports on the tub walls are damaged or missing: remedy as needed.

24. Water ports on the tub walls are damaged or...

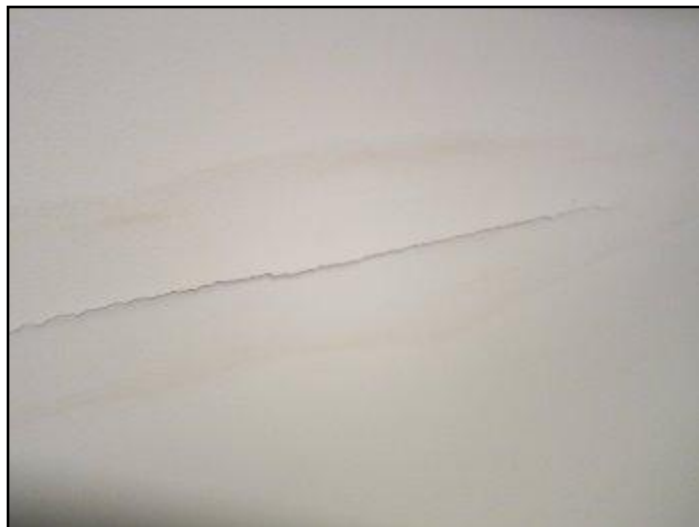
**28. Condition:** • Water damaged drywall on the upper right bedroom closet wall indicates possible water penetration from the roofing vent (stain is located behind the Hall Bathroom commode): evaluate and remedy as needed.

25. Water stain

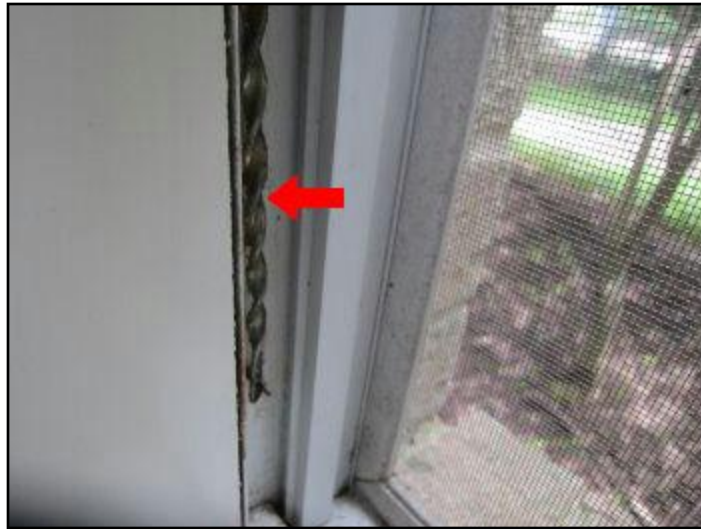
**29. Condition:** • Detached window guide springs will affect performance of the window operation.

26. Detached window guide springs will affect...

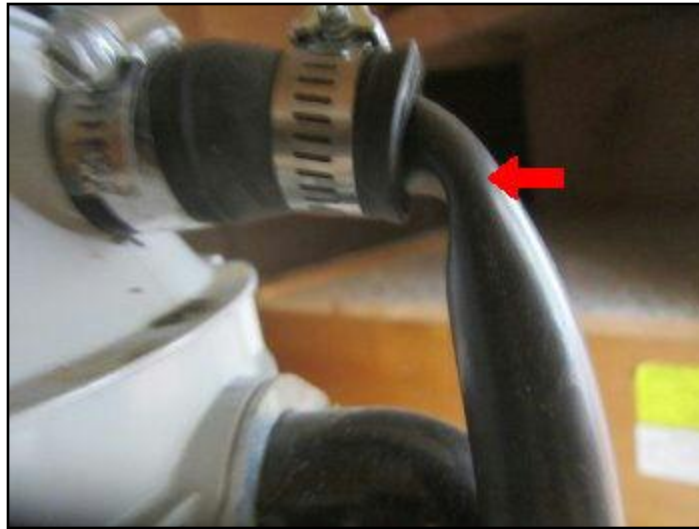
34. **Condition:** • The dishwasher drain line is "crimped" which may reduce water flow.

27. Crimped hose

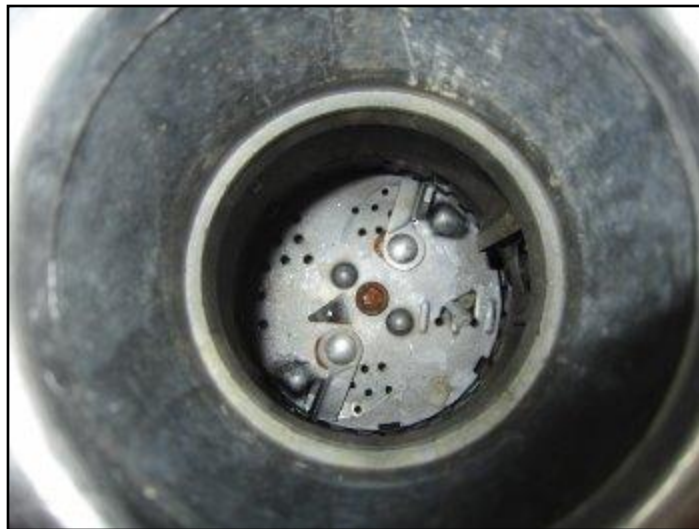
**36. Condition:** • The rubber splash-guard in the sink is missing: replace.

28. Missing guard

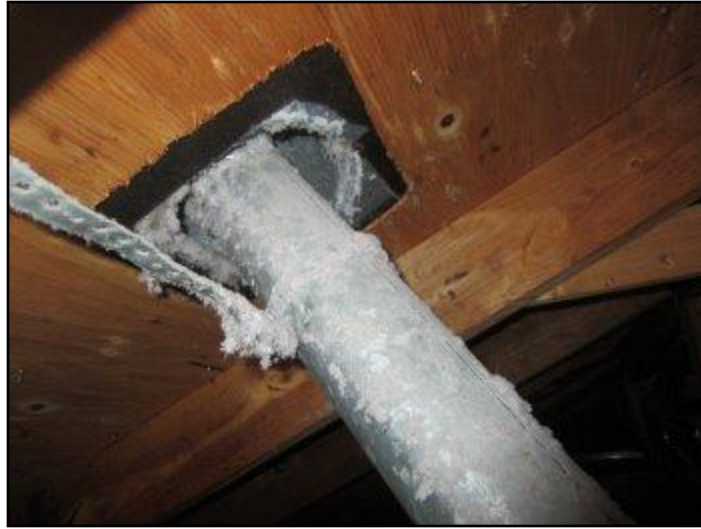
**38. Condition:** • Cleaning of the dryer vent is recommended (maintenance) to ensure unrestricted air flow for proper and safe performance of the dryer.

*29. Cleaning of the dryer vent is recommended...*

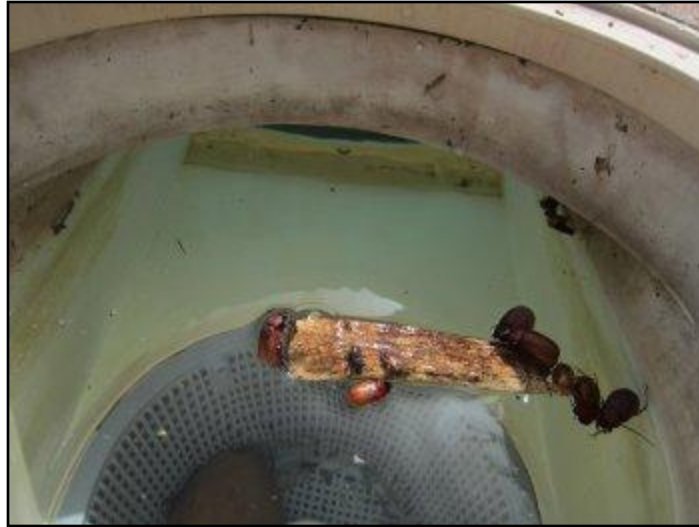
40. • The skimmer box opening "flapper doors" are missing: replace.

31. The skimmer box opening "flapper doors" are...

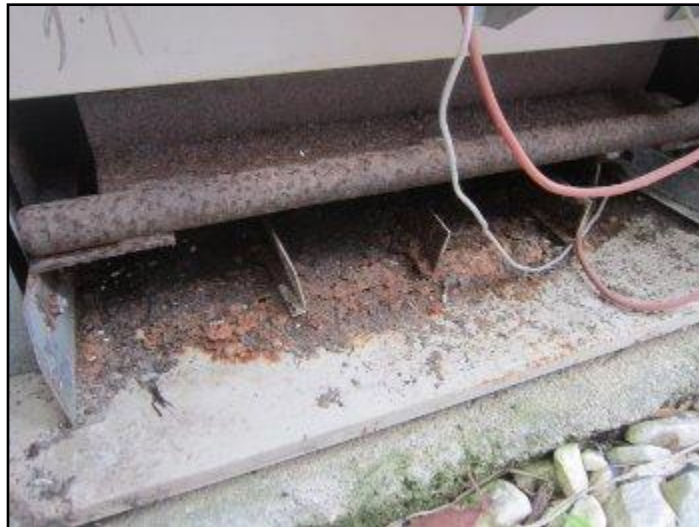
41. **Condition:** • The base of the pool furnace is rusted out: full service is needed prior to operation.

32. Rusted furnace

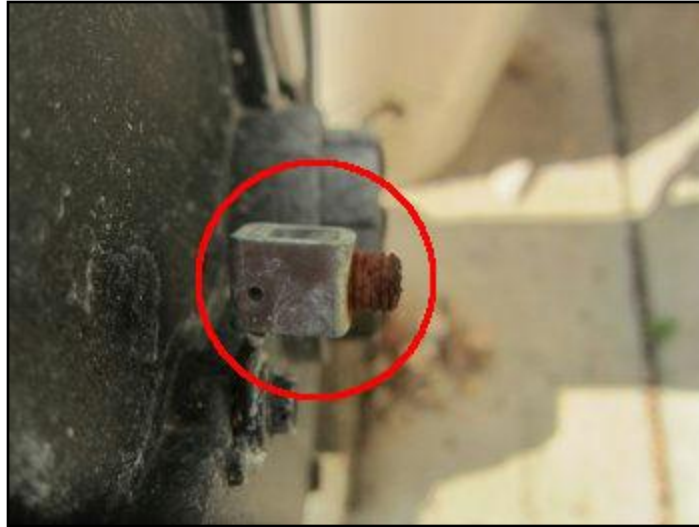
42. **Condition:** • There is no external ground wire attached to the circulation pump motor as designed for safety.

33. No ground

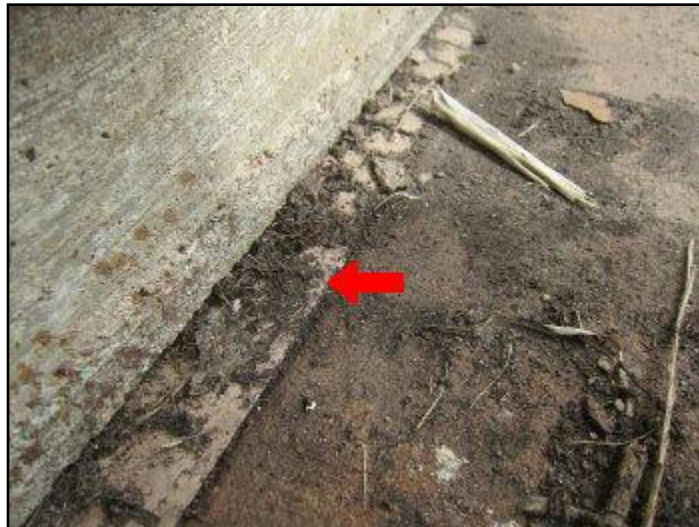
43. Condition: • The parameter drainage grates at the Swimming Pool decking are damaged and/or full of debris.

34. The parameter drainage grates at the...

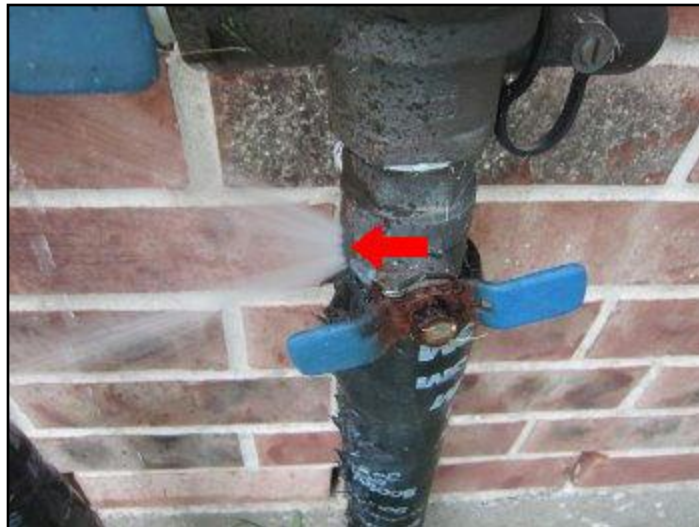
**44. Condition:** • There is a split in the vacuum breaker casement. Due to the split and subsequent water leaking, the system could not be operated. Replacement of the valve is recommended and full evaluation of the system is needed.

35. Leaking valve
